## INFLUENCE OF SHELLAC COATING AND ENVIRONMENTAL CONDITIONS ON CONSERVATION OF AJANTA CAVE PAINTINGS

Tomoko Uno<sup>1</sup>, Yoshiko Shimadzu<sup>2</sup>, Chiemi Iba<sup>3</sup>

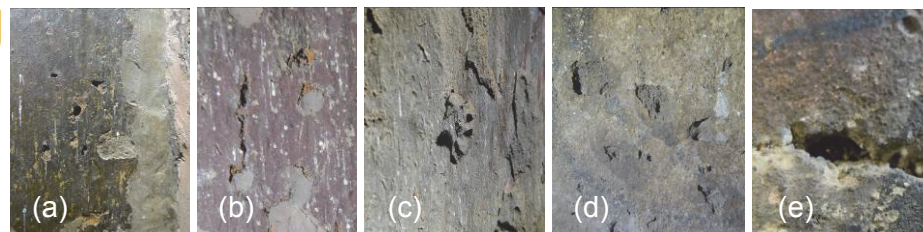
The condition survey of the shellac-coated paintings was conducted carefully. Small holes with typical sizes of a few millimeters can also be observed on the surfaces of the paintings (Fig. 3a). There are visible white lines of accretions at the same parts. The holes appear in conjunction, as reported previously [4, 1]. The paint layers have disappeared in the vicinity of these holes in the wall painting surface, and some holes are connected to others (Fig. 3b-d).

As regards the areas with shellac coatings, the earthen plaster layer has disappeared, but the shellac-coated paint and lime plaster layers remain (Fig. 3a). An insect (*Ptinidae*) was observed inside the small hole in Fig. 3e in the Cave. As the larvae of that insect family create holes inside earthen plaster, there is a high probability that the presence of these insects is related to the deterioration of the earthen plaster.

Fig. 3: Condition of the surface of the paintings (a: There are small holes and white accretions on the surface with shellac coating. b, c: The holes connect to others on the inside of the earthen plaster. d: The paint layer around the holes are disappeared in the paintings without shellac coating. e: There was an insect like to *Ptinidae* in the cracks on the paintings.)

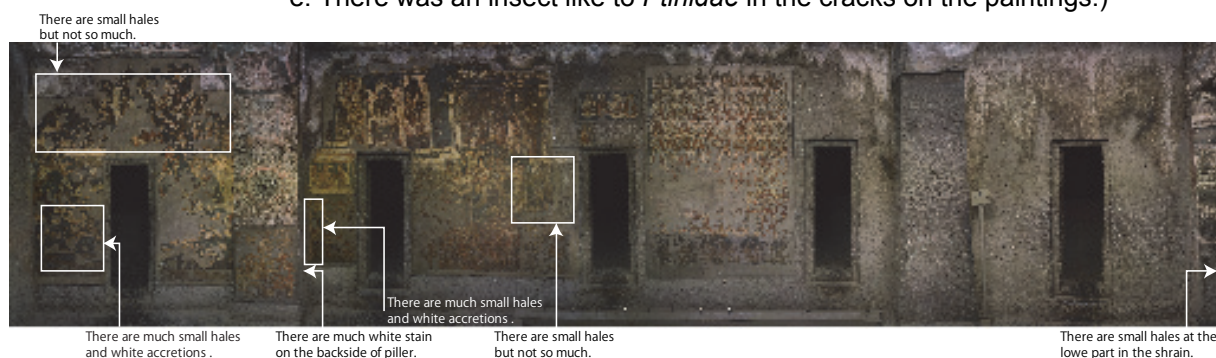
**Distribution of mural painting deterioration:** We examined the wall paintings by focusing on the above mentioned small holes. Fig. 4 shows the areas where the small holes and the white accretions were found. Clearly, the holes are located in the portions of the cave where severe deterioration of the paintings has occurred. There are less holes on the ceilings and upper regions of the walls, while there are more holes on the lower sides of the walls.

Fig. 4: Distribution of the small holes and white accretions on the paintings of the left aisle wall.

**Insect-induced holes:** According to the previous reports [4], the small holes are widespread in all areas of the Ajanta Caves. In this study, we observed the distribution of the small holes in Cave 2 (Fig. 4). Further, during the condition survey of the surfaces, an insect (might be *Ptinidae*) was observed in one of the small holes. According to reports on the conservation of Cave 17, several small insects such as *Silverfish*<sup>3</sup> and *Ptinidae*<sup>4</sup> are identified using bio traps and they distributed throughout that cave [1]. As noted above, because *Ptinidae* larvae usually create holes in bio materials [3], there is possibility that they cause deterioration of the earthen plaster. Usually, these insects lives under darker and moderate condition.

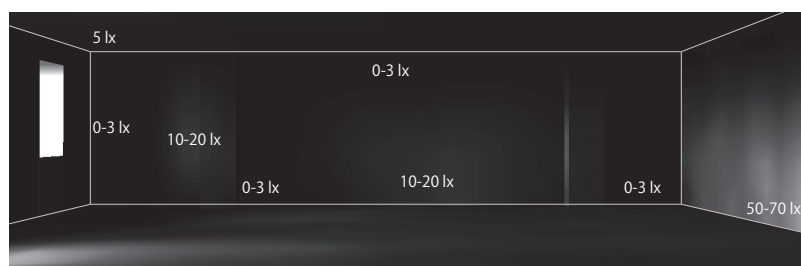
**Lighting Environment:** In order to assess the lighting conditions, we simulated the illuminance of the cave interior using the DIALux computer program [7]. The reflection ratios of the wall, floor, and ceilings were assumed to be 20%. Fig. 5 shows the result obtained for the case in which the sun was positioned at the top of the sky and the sunlight diffusion was high.

Hence, it is apparent that direct sunlight does not enter the cave, except in the case where the sun is positioned at lower 15° and south west in the evening. While the diffused sunlight can enter the cave through the three openings on the west side (Fig. 1), where it can reflect on the floor and walls and weakly illuminate the paintings. The lighting conditions on the front aisle or the back sides of the pilasters are lower than 3 lx and slightly weak in comparison with the surroundings. The areas in which the deterioration involving the small holes is observed correspond to the areas with low illumination. Although the lighting conditions may be one of the factors influencing the distribution of the deterioration features, such as the small holes, this effect cannot sufficiently explain their vertical distribution. Other factors, such as the insect behavior, also have an influence.

Fig. 5: Illuminance distribution on the paintings of the left aisle wall. The *vihala* and shrines are not considered. The places where there are small holes are located under 3 lx.

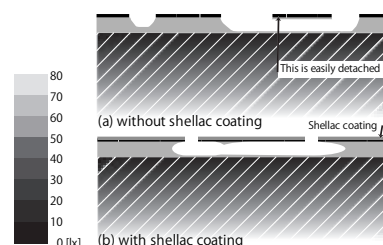
Fig. 6 Mechanism of the deterioration (a: without shellac layer, b: with shellac layer)

regards the paintings without shellac coatings, once the earthen plaster has disappeared, the lime plaster and paint layer (which is harder than the earthen plaster) cannot remain in place for a long period of time. Indeed, it can be detached easily under minimal impact. Thus, the disappearance of the earthen plaster can be directly linked to detachment of the lime plaster and paint layers (Fig. 6a). However, it is possible for a shellac-coated paint layer to remain in place even if the underlying earthen plaster disappears (Fig. 6b). From the above analysis, it is apparent that one of the causes of the earthen plaster deterioration and the paint-layer detachment is the presence of insects. However, the shellac layer prevents the paint layers from detaching from the surface.
