# Investigation of Environmental Factors Influencing the Deterioration of Nikka Stone in Koshien Hall

Tomoko Uno<sup>1</sup> and Kana Noguchi<sup>1</sup>

<sup>1</sup> Department of Architecture, Mukogawa Women's University, Nishinomiya, Japan

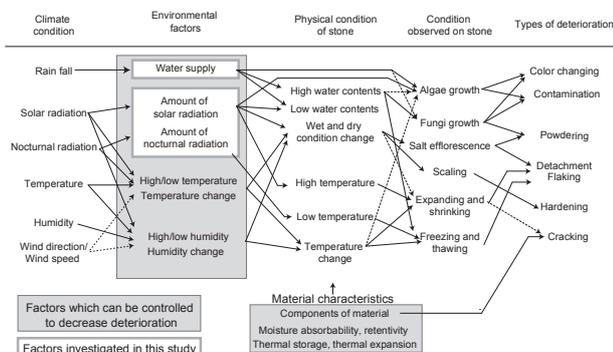
Figure 2. Relationship between environmental factors and type of stone deterioration

Most stone deterioration is caused by the presence of water (Figure 2) and materials with high water absorption capacities tend to maintain water to a greater degree. Water-related characteristics are thus important factors in this study.

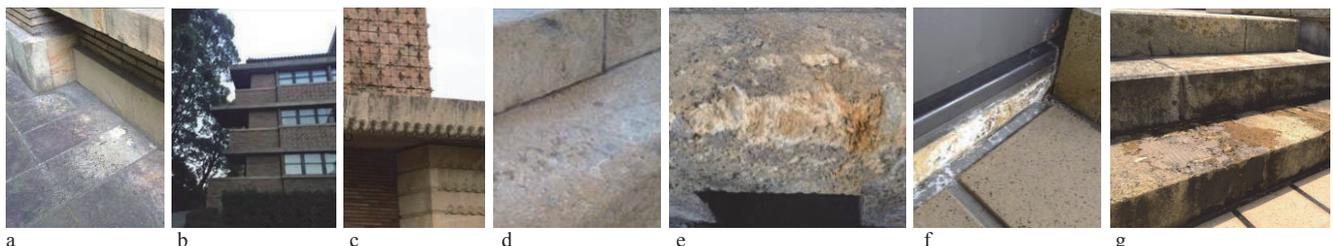
Figure 3. Deterioration conditions

Marked algal growth was observed on the floor stones on the surrounding of West Hall (Figure 3a). Here, most of the Nikka Stone was covered by moss. The ends of the eaves on the west side exterior wall of the West Wing and east side exterior wall of the East Wing were darkened by algae, while the crest tables of the barony wall under the eaves were not darkened (Figure 3b). There are a number of water trace lines caused by algae and dust on the eaves on each south side (Figure 3c).

Several types of detachment were observed. Large detachment tends to occur on horizontal surfaces, such as the stairs of the 2F roof terrace (point B, Table 1) and the crest table on the north side of the 3F roof terrace (point C, Table 1). Fine detachment, such as flaking, was observed on the surface of the outside floor on the east and west sides of the West Hall (Figure 3a), on the exterior steps at the front entrance, on the stairway of the terrace at the south side in front of the lobby in 1F (point A, Table 1 and Figure 3d), and in other locations. Algae were not observed on these flaking areas. Detachment with salt efflorescence was observed on the lower side of the pillars on the south side terrace of the 1F lobby (Figure 3a) and in other

Salt efflorescence appeared in small limited areas, such as on the lower parts of pillars on the south terrace of 1F (Figure 3e) and on baseboards under the entrance doors of 3F (Figure 3f). The causes of salt efflorescence include repeated cycling of dry and wet conditions, i.e., changes in moisture content of materials and temperature changes in the presence of salt.

Steps: Algal contamination and detachment of several sizes were observed. Nikka Stone was significantly darkened by thick algal growth (Figure 3g). Compared to the top stairs in area I of point B in Figure 4, there was much more algal growth on the second, third, and lower stairs. In addition, large detachment was observed in area II; one instance was about 15 cm wide and more than 5 mm thick.

a) Algal contamination and detachment at the floor stone, b) Algal growth in the west side of West Hall, c) darken trace of the eaves, d) flaking on the stairway of the terrace at the south side in front of the lobby in 1F, e) detachment with salt efflorescence on the lower side of the pillars, f) salt efflorescence on the baseboards under the entrance doors, g) detachment and algal growth at the center stairs on the 2F roof terrace, point B.

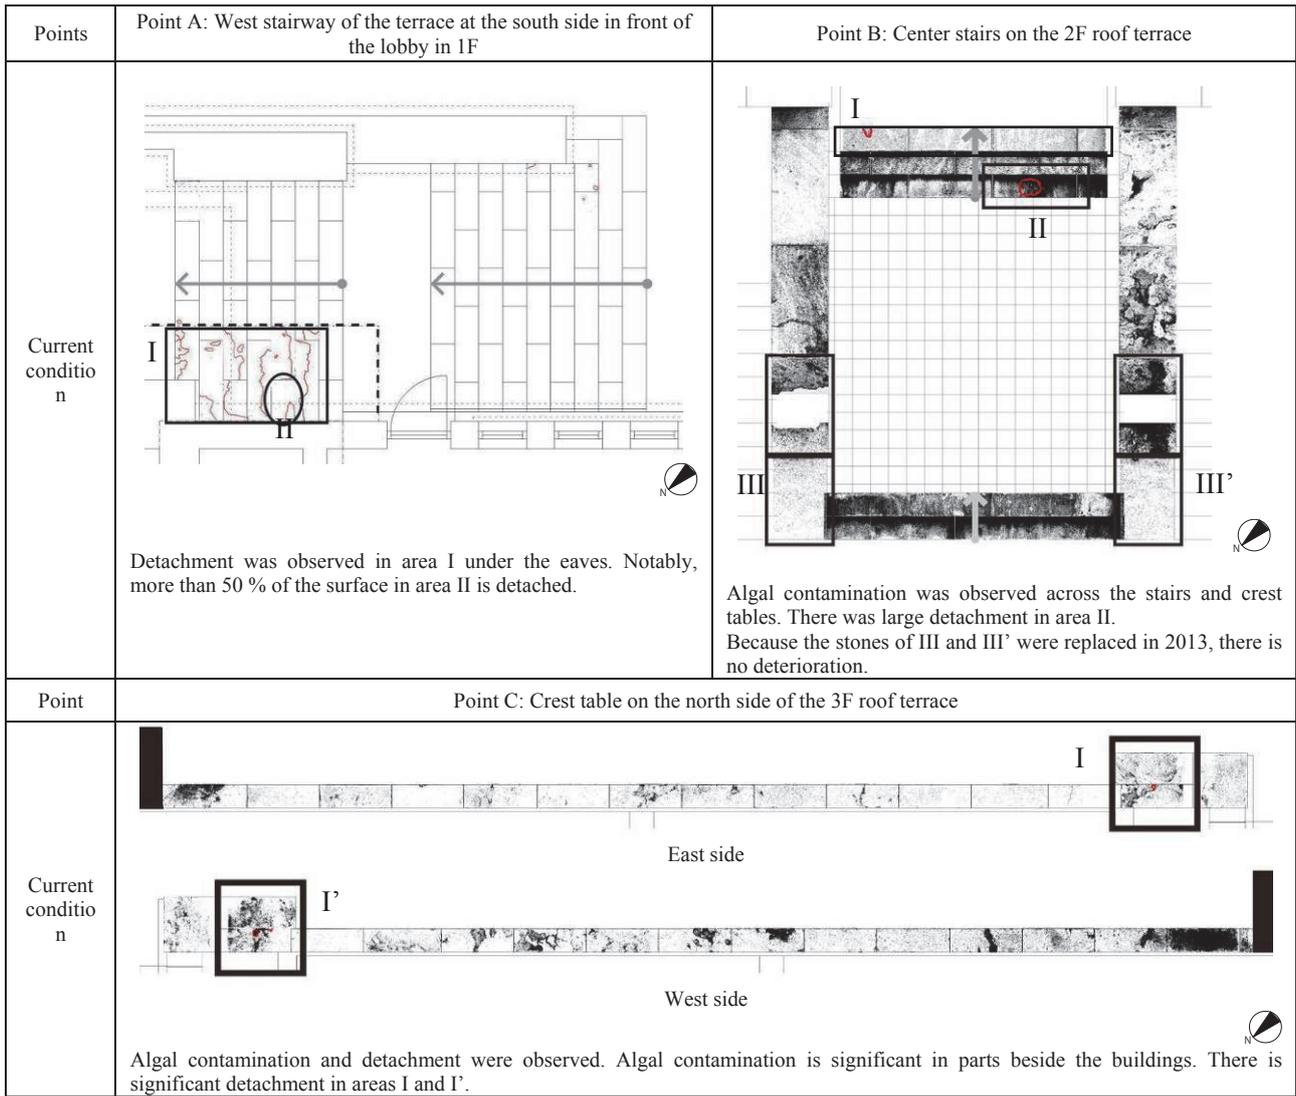
Figure 4. Current conditions in areas of typical deterioration at points A, B, and C

Fine detachment flaking was observed only on the north side of the upper stairs (Figure 3d, Figure 4: the inner side of the dotted line at area I of point A). The flaking area comprised approximately 1/3 of total area. Other areas were in good condition. Water repellent materials had been applied to the surface of the Nikka Stone here in 2009<sup>1</sup>. Even now, water films are observed during rain; the effect of the water repellent thus remains. Visual observations confirmed that there is no salt efflorescence.

Crest table: Algal contamination and detachment were observed. Algal growth was less extensive than on the steps. There were several instances of small detachment compared to the steps, some of which had been repaired with mortar. The crest tables of III and III' in Figure 4 were replaced with new materials in 2013 because of serious deterioration.

Areas with detachment damage at area I in point A in Figure 4 were shadowed from rain. It is therefore thought that the water supply from the surface is small and that water may originate from neighboring rain-exposed stones. Although these areas have low sky view factors compared to other areas of B or C, the south side is open and the area is influenced by direct solar radiation at noon. When there is a water source, which should be from the back side of the stone, constant evaporation from the surface of the stone under the eave should occur. Additionally, water repellent would prevent evaporation from the surface, while evaporation would be concentrated and would continue in deteriorated areas without water repellent.

Factors contributing to detachment damage at point A should therefore be increasing temperature, drying caused by solar radiation, concentrating evaporation on the surface along with water supplied from nearby stones, and wetting/drying cycles. The effect of water repellent on salt efflorescence requires more detailed investigation and experimentation.

Crest tables: Detachment (of several sizes) within the stones, which are filled with mortar, are the main causes of deterioration. This area has high sky view factors and slightly low water

content. Slightly high water content was measured after rain only on the north side of the crest table stone in III and III'.

Except at the two latter locations, some halls have been filled with mortar, which tends to have low water penetration and low water content. Although rainfall on the stone is high, it drains immediately afterwards and the upper portions dry out (except in III and III'). In order to prevent algal contamination, use of water repellent can therefore be effective. However, some water remains on the surface in the small hall, and water content can be high, causing freezing and thawing damage; the surface should therefore be smoothed with a material like mortar or resin.

Because III and III' stones are laid at a lower position than other stones, rainwater flows on to them and persists for a long period of time. In addition, in parts of III and III' that were replaced with new material last year, the stone surface is not covered by mortar or resin and water can easily penetrate. These parts receive substantial water from the upper side, so waterproofing should be applied to the surface and to the back part. There is currently no detachment; however, there is a high possibility of deterioration caused by freezing-thawing occurring in future.

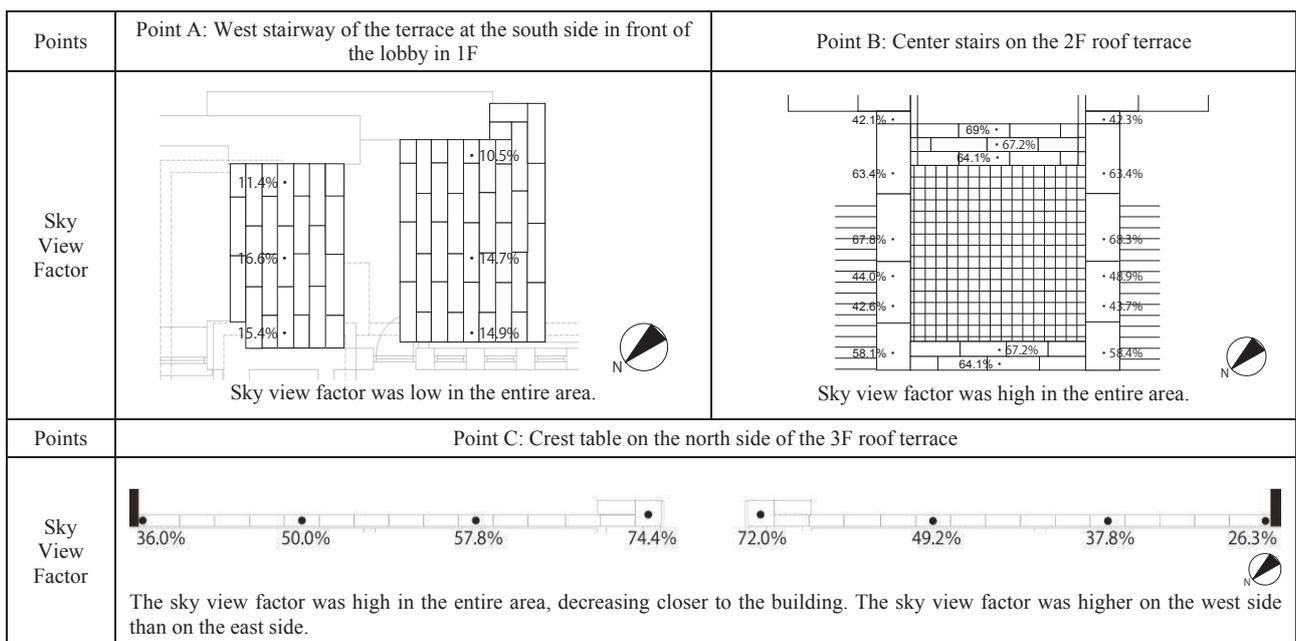
Figure 5. Sky view factor in areas of typical deterioration at points A, B, and C

Sky view factors were low (between 10–17 %) and part of the zenith was covered by an eave. Rain therefore rarely fell on the steps and there was less solar and nocturnal radiation.

The sky view factor was high (between 42–69 %). Rainfall, solar radiation, and nocturnal radiation were therefore high.

The sky view factor was high (between 72–74 % at the center and between 26–36 % at the west and east sides). A lot of rain therefore fell here, and solar radiation and nocturnal radiation were high. Closer to the sides of the west and east buildings, the sky view factor was lower because of the presence of a large tree on the north side of the west part of the building.

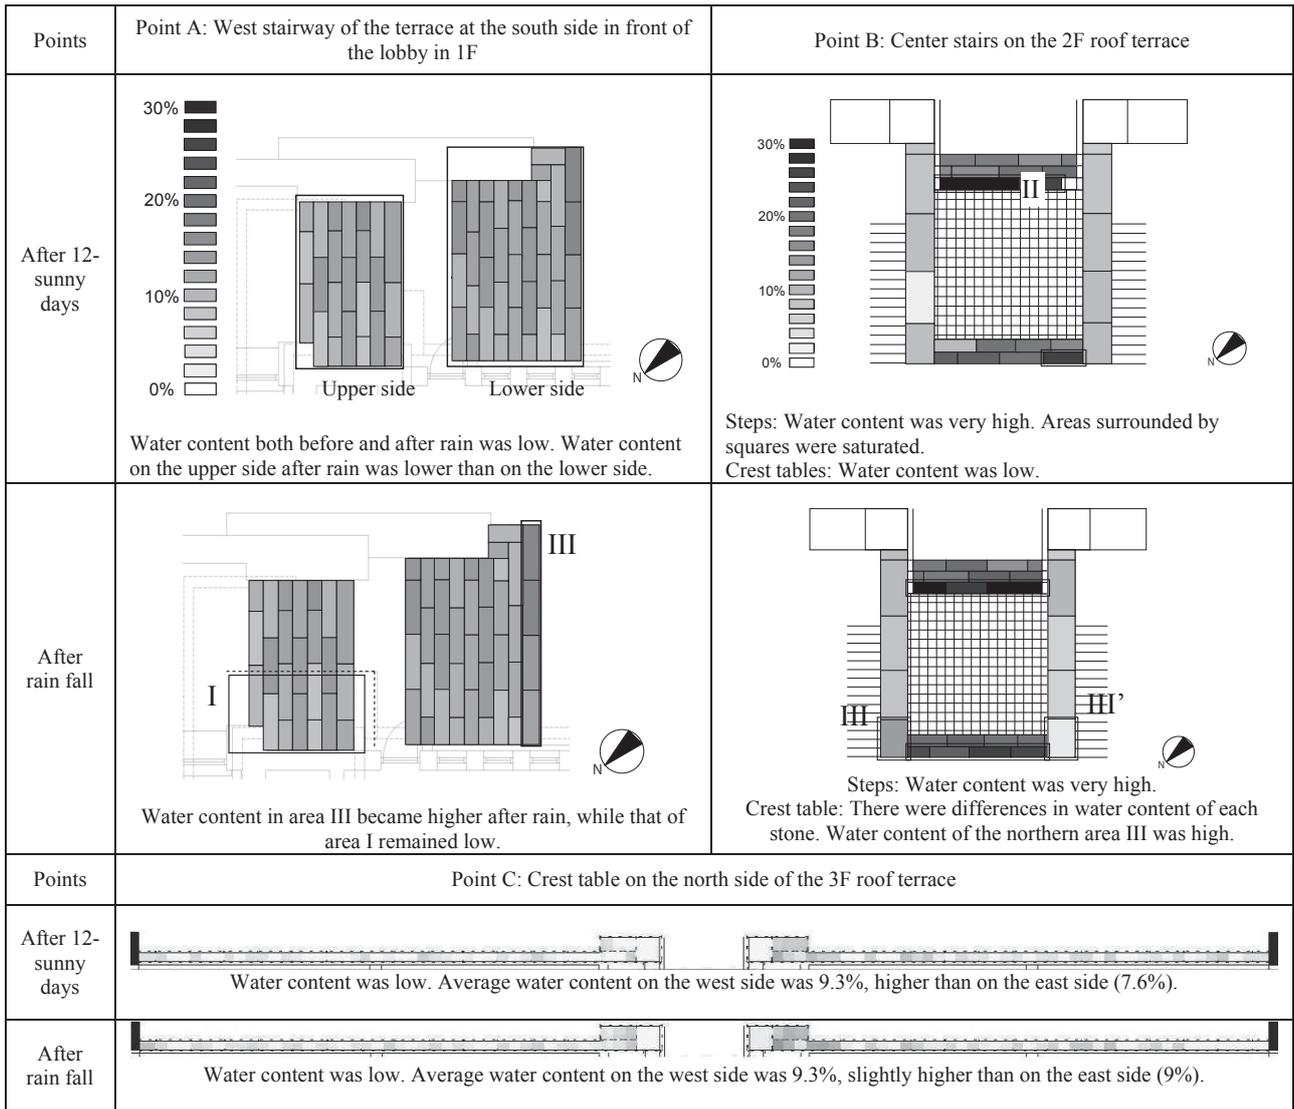
Figure 6. Water content in cases of typical deterioration at points A, B, and C

Water content was low (around 8–15 % before rain and around 10–18 % after rain) everywhere; in particular, the water content of places under eaves was relatively lower, even after rain.

The water content was around 15–18 % (before rain) and 15–21 % (after rain) at the top stair, while that of steps below the second step was 15–30 % (before rain) and 19–32 % (after rain). The water content of the lower side is obviously high, and in area II was over 23% (saturated conditions). These points were thus wet all the time.

Water content was low everywhere, at 2–12 % before rain and 3–14 % after rain. It should be noted that, even when there was significant rain, this location dried out quickly.

Steps: The areas of color change induced by water increased a few days after rain at the lower part of the steps. On the third step from the bottom, the area of color change induced by water did not disappear by ten days after a rain event.

Steps: Detachment and algal contamination were mainly observed. Water content was high and area II in Figure 6 was always wet. Because wetness appears and spreads a few days after a rain event and continues for several days, water supply is too excessive to be explained by rainfall onto the surface. Since there are wide 3F roof terraces without roofs on the upper side of point B, the rain water falling to the 3F terrace can seep through the mortar joints to the lower steps. After the surface of the terrace has dried, water might remain under the tiled floor of the 3F roof terrace and flow to the back side of the stone on the steps. This may be the source of water leading to the high water content of the steps. Water supply is substantial and persists for days.

Because of this constant water supply and high sky view factors, freezing and thawing occur and damage the stone. However the high heat capacity of Nikka Stone that absorbs solar radiation during daytime works to maintain heat and can buffer the decrease in surface temperature. These effects should be carefully simulated. High water content also causes substantial algal growth. It is therefore better if water supply is decreased.
