SPATIAL COMPOSITION OF THREE INTERMOUNTAIN SETTLEMENTS LOCATED ON SLOPES IN NORTHERN AND CENTRAL TURKEY

Toshitomo Suzuki¹, Shigeyuki Okazaki¹

¹ Mukogawa Women's University, Japan

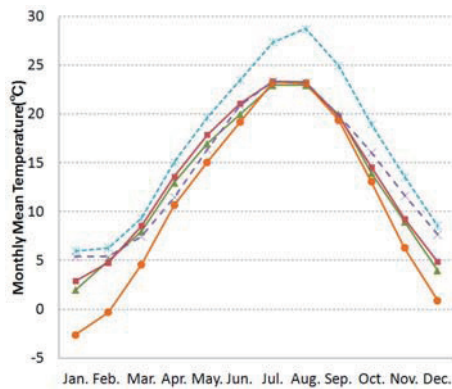
Fig. 2: Comparisons of monthly mean temperatures [1]

We compared the monthly mean temperatures and precipitation in Karabük City (about 15 km east of Bolkuş), Amasya City (about 13 km southwest of Çiğdemlik), and Divriği Town (about 6 km south of Demirdağ) (Fig. 2, 3).

The four seasons are clearly differentiated in these cities, as in Istanbul. The differences of the mean annual precipitation in Karabük (488 mm), Amasya (447 mm), and Divriği (387 mm) [1] are lower than that in Istanbul (697 mm). The precipitation in summer (Jun. to Sep.) is lower than in winter. Karabük has the highest precipitation in summer, followed by Amasya and Divriği. The Köppen-Geiger climate classification [4] places Karabük in the humid subtropical climate, like most of Japan and parts of China and South Korea, and Amasya and Divriği in the Mediterranean climate in the Mediterranean Basin. The two climates are classified based on

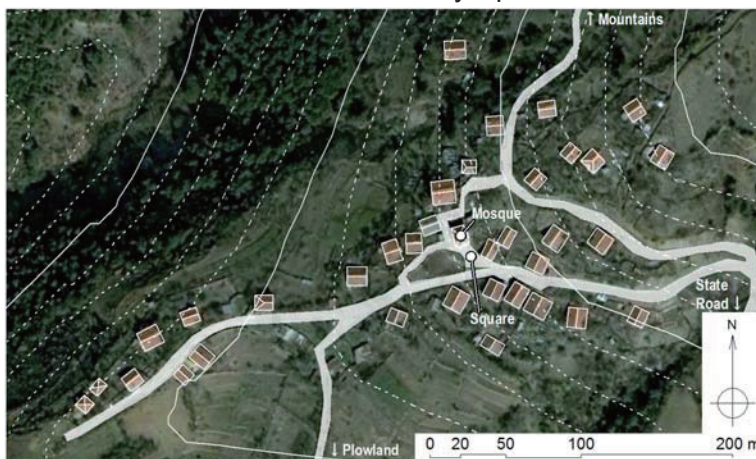
Fig. 5: Closeup satellite image, contours and map of Bolkuş Yalnızca Settlements 1:5,000

Geography (Fig. 4, 5): Two independent settlements are surrounded by green mountains. Filyos River, State Road D030, and a railway run through the bottom of the valley. The south settlement is located on the gentle slope of the river's south side. The north settlement, called Yalnızca, is on the steep slope, which is about 120 to 200 m higher than the south.

Satellite image in 2005 [2] : © 2012 Google, © 2012 Cnes/Spot Image, Image © 2012 DigitalGlobe
Contours (10 m intervals) [3][6] : GeoMapApp © <http://www.geomapp.org>

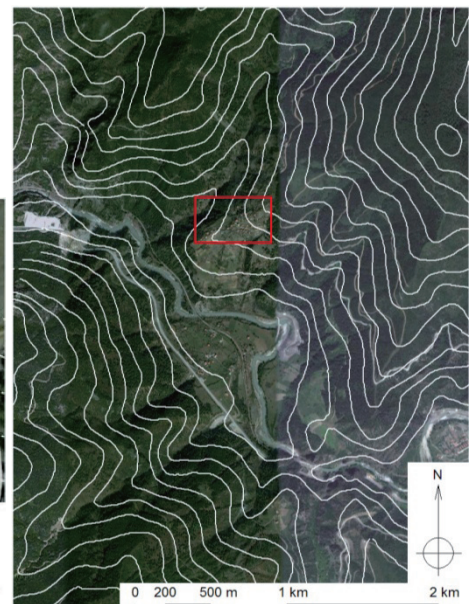
Fig. 4: Satellite image and topography of Bolkuş Village 1:50,000

See Fig. 5 for closeup in framed rectangle.
Satellite image in 2005 and 2011 [2] : © 2012 Google, © 2012 Cnes/Spot Image, Image © 2012 DigitalGlobe
Contours (50 m intervals) [3][6] : GeoMapApp © <http://www.geomapp.org>

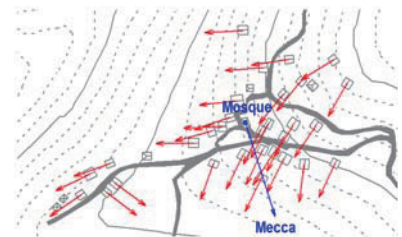
Fig. 14: Aspects of gable houses and mosque in Bolkuş Yalnızca Settlements 1:10,000

Buildings: Many gabled houses shared similar scales sides faced the valley (Fig. 11, 12, 14). They created a sense of unity among the houses when they were viewed from the other side of the river (Fig. 6).

Unlike the other houses, the mosque faced Mecca (south-southeast). Its form and color were different from the other houses (Fig. 7).

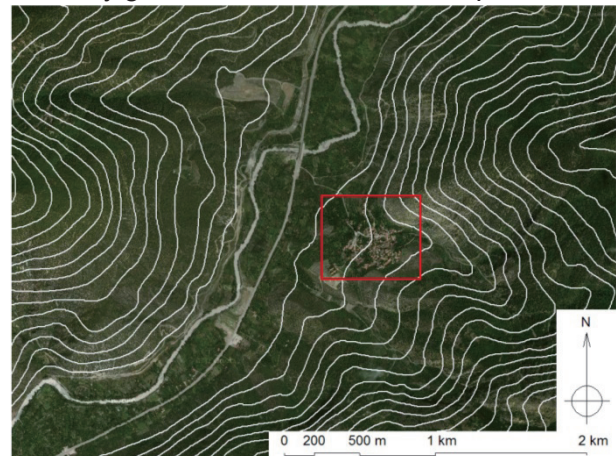
Fig. 15: Satellite image and topography of the Çiğdemlik Village 1:50,000 See Fig. 16 for closeup in framed rectangle.

Geography (Fig. 15, 16): The settlement is surrounded by green mountains. However, parts of the mountainsides near the settlement have just a few trees. Yeşilirmak River and State Road D100 run through the bottom of the valley.

Satellite image in 2010 [2] : © 2012 Google, © 2012 Cnes/Spot Image, Image © 2012 GeoEye
Contours (50 m intervals) [3][6] : GeoMapApp © <http://www.geomapapp.org>

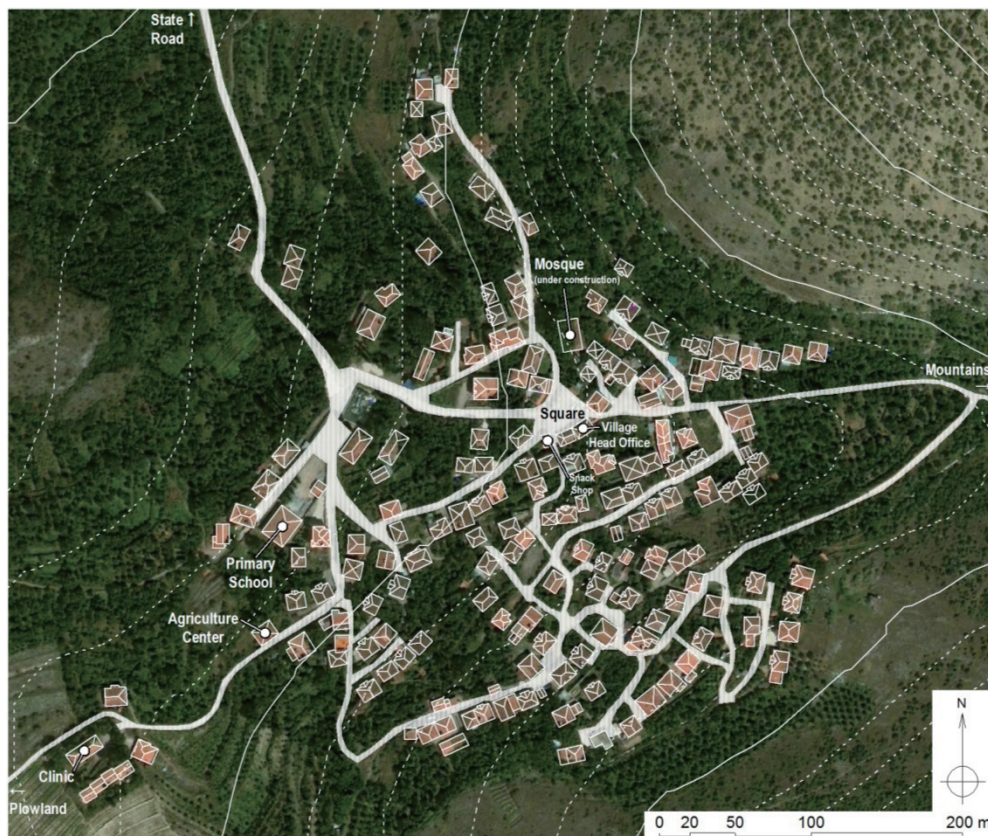
Fig. 16: Closeup satellite image, contours and map of Çiğdemlik Settlement 1:5,000
 Satellite image in 2010 [2] : © 2012 Google, Image © 2012 GeoEye Contours (10 m intervals) [3][6] : GeoMapApp © <http://www.geomapapp.org>

Settlement: The settlement was on a slope from the state road through the upslope road. The houses were spread like a fan. A

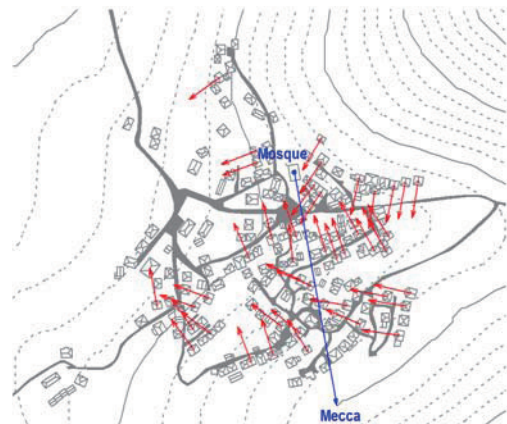
Fig. 25: Aspects of facades in Çiğdemlik Settlements 1:10,000

Buildings: The old houses shared a characteristic facade with an overhanging gable, a front wall, and a window upstairs (Fig. 21-23). The facade faced the lower altitude rather than the nearby road (Fig. 25). Some of the houses were visible from the lower altitudes with hipped roofs and a small gable and from higher altitudes as one gabled wall (Fig. 24). The color of the

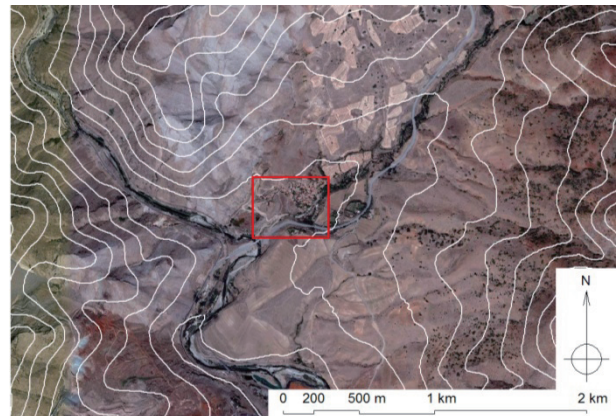
Fig. 26: Satellite image and topography of Demirdağ Village 1:50,000. See Fig. 27 for closeup in framed rectangle.

Geography (Fig. 26, 27): The settlement is surrounded by gentle bald mountains. Trees are limited to inside the settlement and near a stream.

Buildings: Many houses had hipped or pavilion roofs. Although some houses had gable roofs, few gable walls faced the lower altitudes. The walls of the houses varied in color. However, red roofs and the similar scales of most of the houses created a sense of unity when viewed from a distance (Fig. 26). Some houses had overhanging upstairs (Fig. 34, 35).

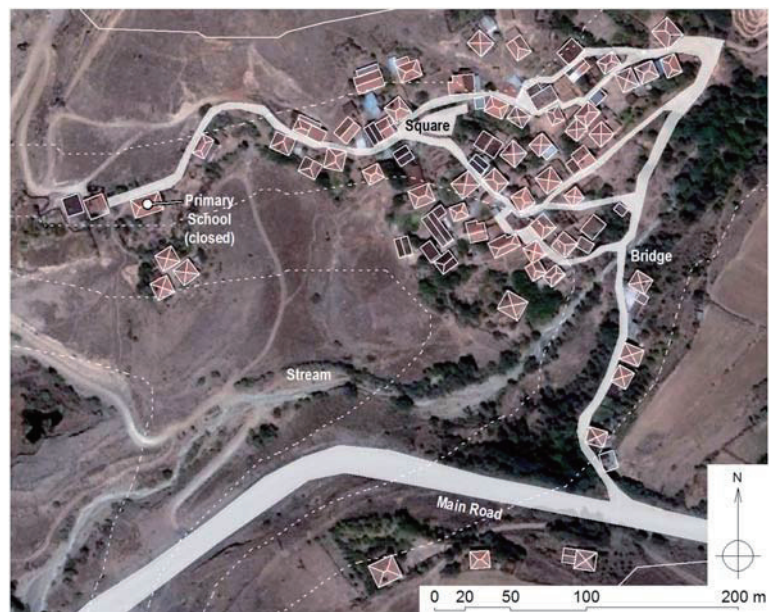
Fig. 27: Closeup satellite image, contours and map of Demirdağ Settlement 1:5,000

Settlement: The settlement was on a slope approached from the main road through a downslope road and a bridge over a stream (Fig. 28, 29). There was a square in its center (Fig. 30). A primary school at the west edge of the settlement had been closed. There was no mosque in the settlement. Many settlements around Divriği have no mosques.
