CARAVANSARIES: THE ARCHITECTURAL TREASURES OF SILK ROAD AND THE CASE OF KAYSERI-SULTANHANI

Gonca Büyükmihçi

Erciyes University, Turkey

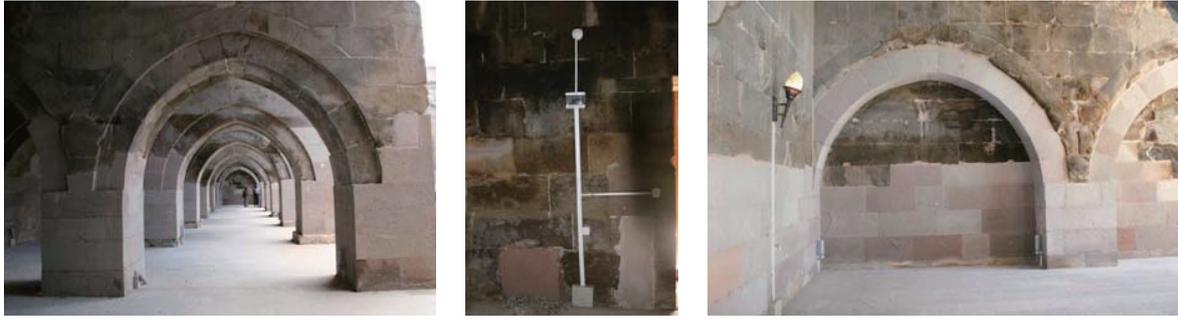
Figure.9. Sultanhan's restoration problems

The new walls which are completed incompatibly with the unique walls, the discordant stones used on arches and vaults, illumination elements, the discordant appearance of cables and insurance boxes, overflow of grouting, and stairs exaggerated reinforcement applications at the foot of courtyard riwaqs, sloppy workmanship reduced to a special quality of the building and caused and a negative visual impact on the general appearance of the building. In addition to the negative impact of this conservation, some other technical problems such as intensive salination and discharges were occurred due to the construction of a new roof.

The first comprehensive repair was realized by the regional directorates of Waqfs. By this restoration even though the building got rid of destruction but lost most of its unique characteristics because of the insufficiency of preliminary surveys and technical analysis. After this maintenance which was done against the principles of contemporary conservation, another restoration project was prepared for the time worn building and was approved in 2006. The main decisions of this restoration project are criticized in terms of the lack of adornment repetition and lack of integration between the stairs and the usage of contemporary material in some part of the building. Even though these applications do not have a contrast with contemporary restoration principles, they are not considered as a successful conservation in terms of the quality of the structural maintenance, unqualified materials, insufficiency of conservation implementations comprised of unique mortar and connective analysis
