RESEARCH OF ANTI-FREEZING FOR THE BUDDHIST IMAGE CARVED ON TUFF CLIFF BY CLOSING SHELTER

Masayuki Morii

National Research Institute for Cultural Properties, Tokyo, Japan

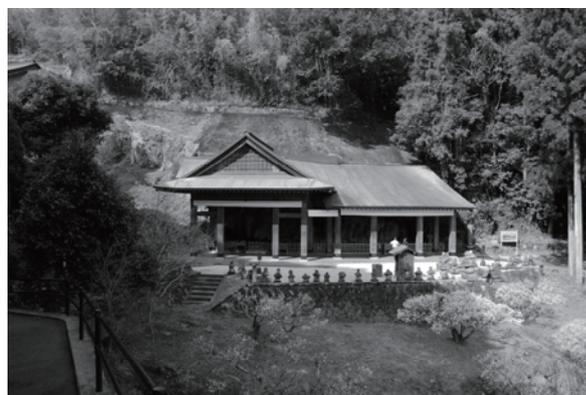
Fig. 2: Shelter of the Usuki stone Buddha (Hoki second cluster)

In Japan, the shelter has often constructed at the Buddhist images carved on natural cliff for conservation themselves, especially they have been prevented from rain and inflow. The Usuki stone Buddha also has been constructed the shelter with wide roof about twenty years ago (Fig. 2). At first, the shelter of Usuki stone Buddha was compared with one of other Buddhist images by using "ventilation rate (the ratio of aperture area to volume in the shelter)" in order to confirm its conservation ability. Each shelters were classified under four

types from the viewpoint of whether its side wall were installed or not and how width of each roofs.

Table 1 shows the ventilation rate and monthly mean value of diurnal range between outdoor and indoor on August. If the shelter was closed, temperature change in the shelter was smaller than the others. However, it was observed that temperature change was small like a closed shelter in the Usuki stone Buddha although its side walls were not installed.

It was estimated that the reason why temperature change was small was low impact of sunshine and radiation cooling because of wide roof in the Usuki stone Buddha. And it was also estimated that freezing was caused not by radiation cooling but advection of cold air.

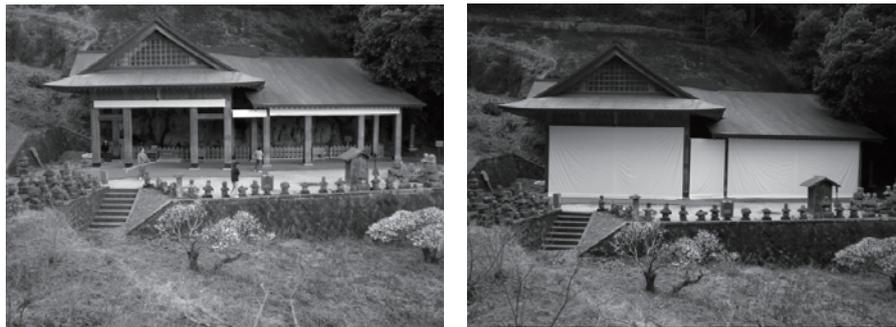
Fig. 4: The method to control a cold wind

Heat lump was effective to prevent the Buddha surface from freezing, but it might help the vegetation growth. So the polyester curtain was installed each entrance of shelter and it was closed during the nighttime when it was cold (Fig. 4). And temperature and air current in the shelter was measured.
