# Investigation of Environmental Factors Influencing the Deterioration of Nikka Stone in Koshien Hall

Tomoko Uno<sup>1</sup> and Kana Noguchi<sup>1</sup>

<sup>1</sup> Department of Architecture, Mukogawa Women's University, Nishinomiya, Japan

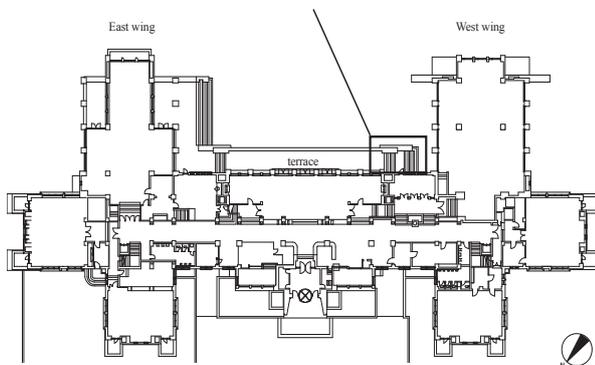
Point A: West stairway of the terrace at the south side in front of the lobby in 1F

Environmental observations were carried out at places where typical deterioration was observed during the preliminary investigation (shown in Figures 1 and 4, points A, B, and C). The main types of deterioration observed at these points were detachment and algal contamination.
