## EVOLUTION OF TIMBER CONSTRUCTION IN TURKEY

Görün Arun

**Keywords:** timber construction technique, timber dwellings, Anatolian timber architecture.

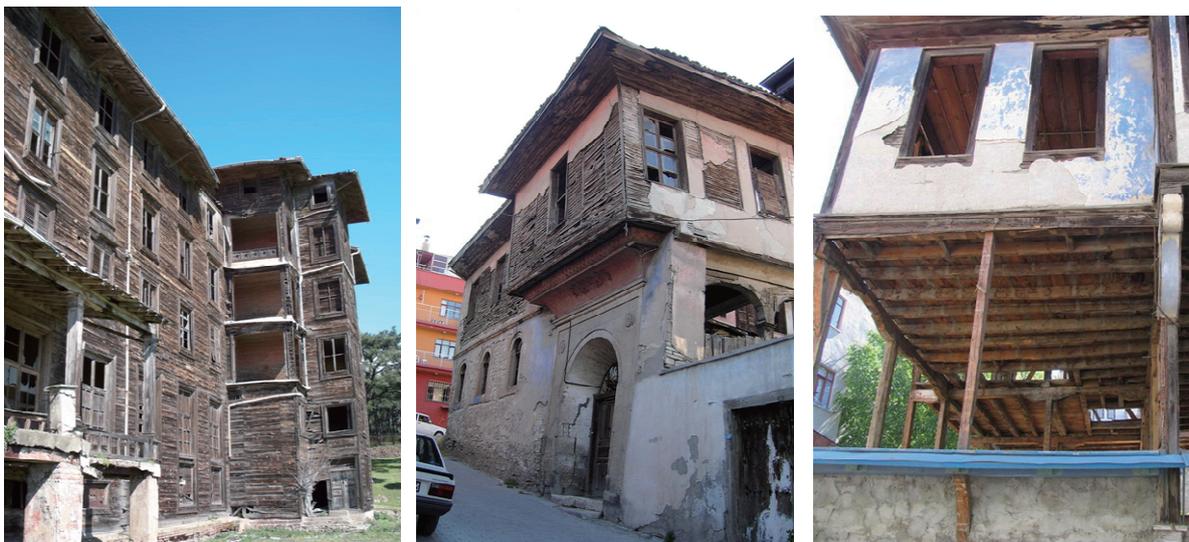
Fig. 2: Timber houses rise on foundation wall, on masonry wall and on columns

The foundations of timber walls were of masonry, later of concrete. The timber walls of one or more stories in height were supported on the foundation walls, on timber laced masonry walls of the ground floor or raised on cripple studs or post and beam supports (Fig.2). In the first two cases, the masonry wall top is covered with a layer of lime mortar where timber sill beam is placed forming a level set for the timber wall. The footings of the timber columns are either anchored in concrete or masonry foundations or placed on a big footing stone.

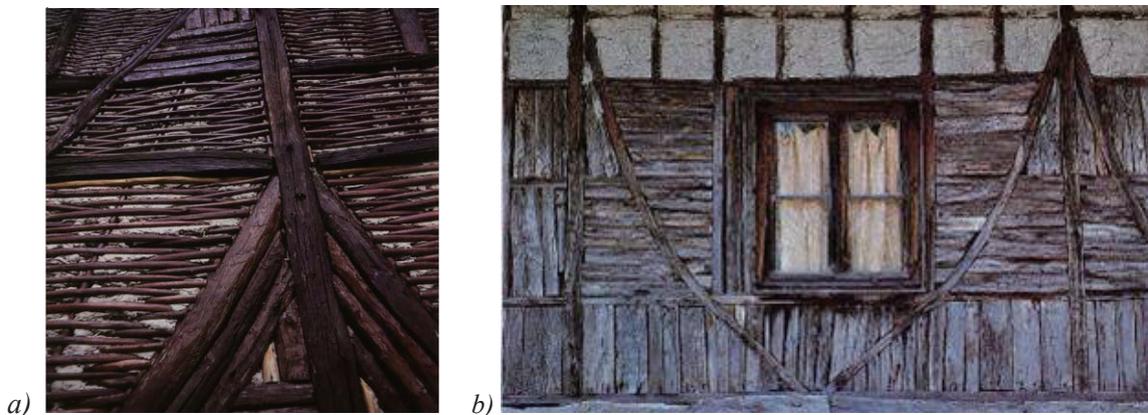
Fig. 3 Timber filled frames

*Totally timber framed walls'* columns/studs spacing is either 40-150 cm. If the spacing is more than 60cm, the frame is braced horizontally and diagonally. Space between the studs are filled or covered with timber. When the studs are closely spaced, the space is woven with wattle and daub and called "çöten (choten)" walls (Fig.3a). The frame with widely spaced studs are filled with timber and called "dizeme (Fig.3b). If closely spaced laths are nailed on both sides of the frame's columns/studs and then plastered, the wall is called "bağdadi = lath" walls (Fig.4a). In timber veneered frame, the sawn timber planks are nailed on the outer side of the frame (Fig. 4b). The inner face of the wall may be covered by lath and plaster or timber veneered.

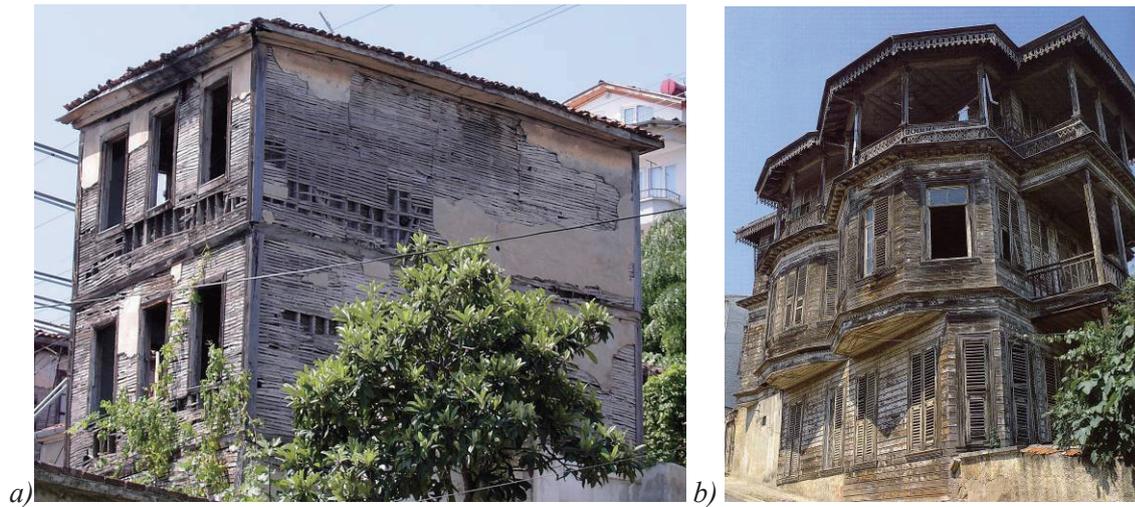
Fig. 4: Timber covered frames

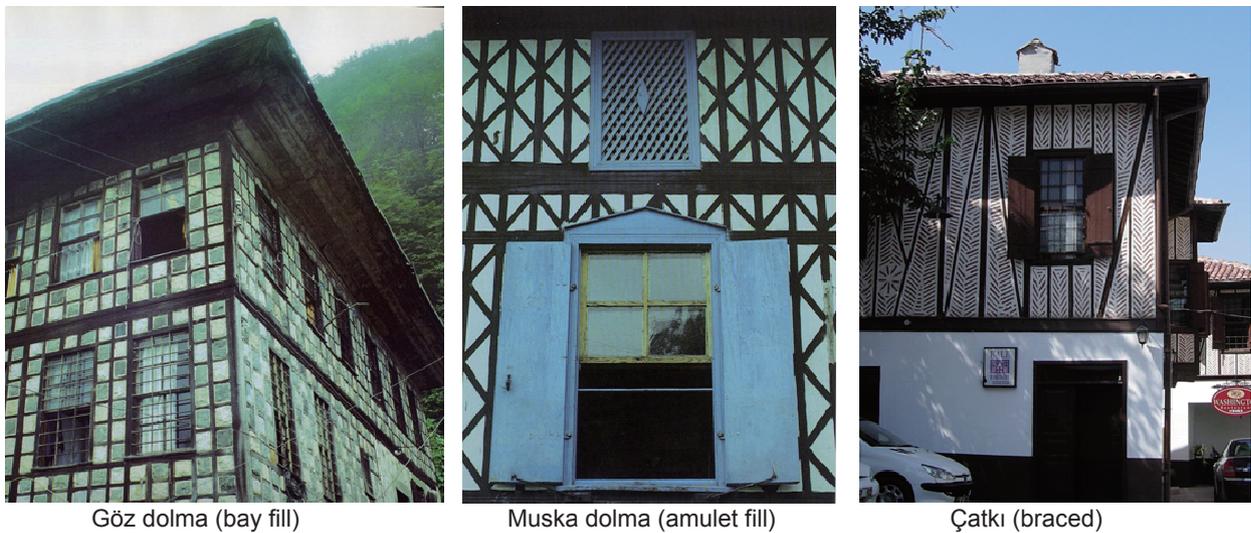
Fig. 5: Hımiş (composite) frames

*Composite timber frames* are made of timber frame with stone, adobe or brick infill. The houses constructed with this system are called “hımiş” pronounced as humush. Depending on the available material and carpenter’s ability, such composite timber framed walls of wide ranging typology are composed by either 22-60 cm spaced columns / studs or 60-150 cm spaced columns with horizontal and diagonal bracings. Hımiş style houses generally rested on a heavy stone first floor wall and named according to their formation as *Göz dolma* (Bay fill), *Muska dolma* (amulet fill) and *Çatki*.(braced) frames (Fig.5)
